Traffic Finial Assembly – Moisture, Carbon and Insect Barrier

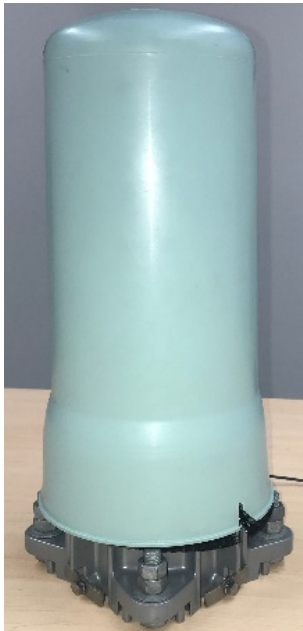
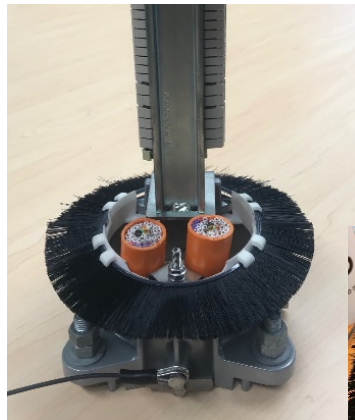
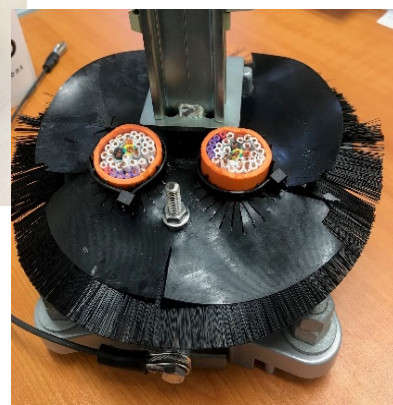
- **Strong Bristle Brush** - Carbon and Small Insects entering base of the finial
- **Hydrophobic Gasket** - Moisture entering from pole into finial
- **Retrofit Installation** – no need to disconnection of existing 36core cables
- **Reduced Maintenance and Repair Costs**
- **Reduces RISK** and promotes a **SAFER Working Environment**
